5/29/2015

JOHN HYLAND
CONSTRUCTION

EXECUTIVE SUMMARY REPORT

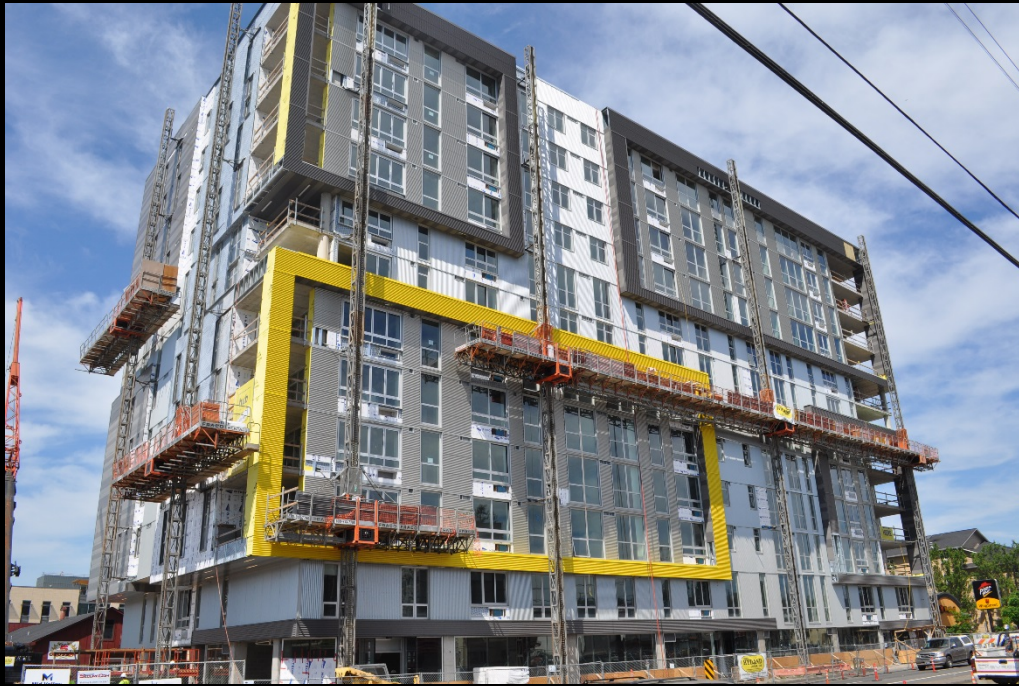
South elevation nearly complete

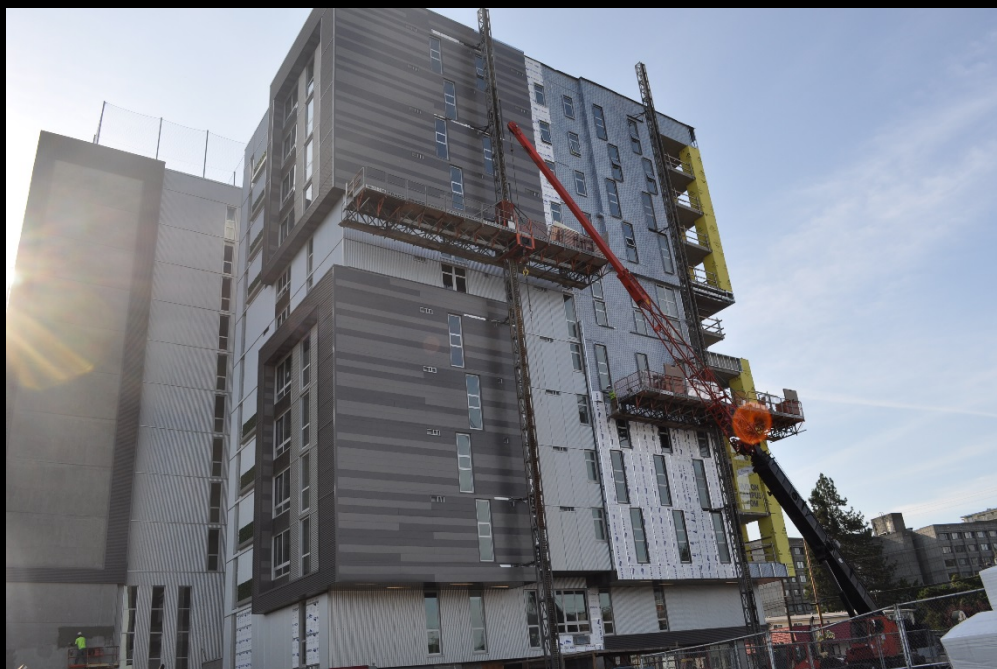
West elevation rigid insulation installed at elevator hoist build back

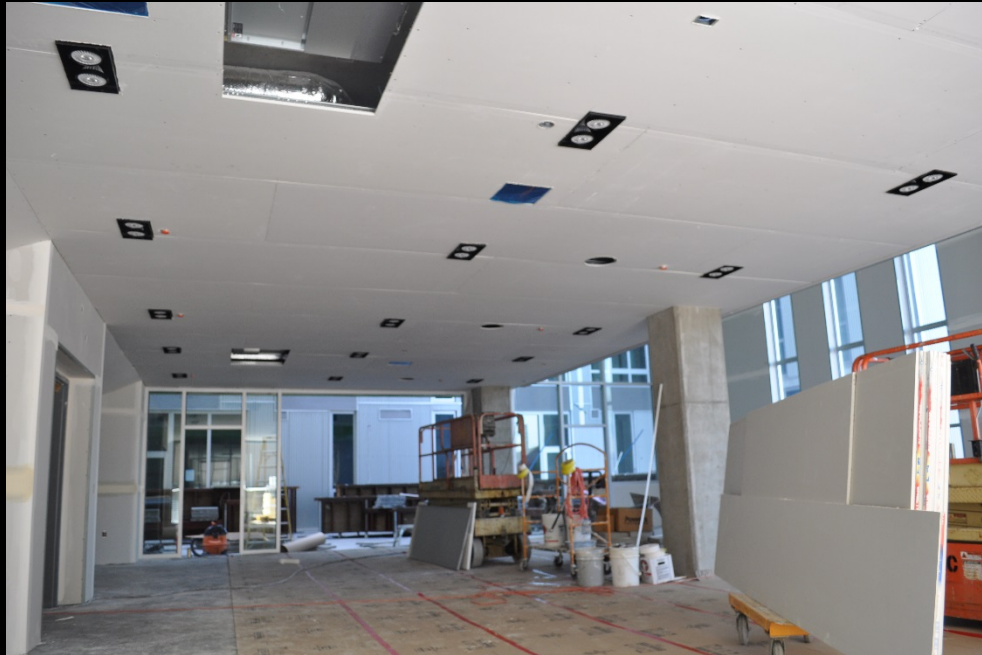
Drywall installed at Club
Room ceiling

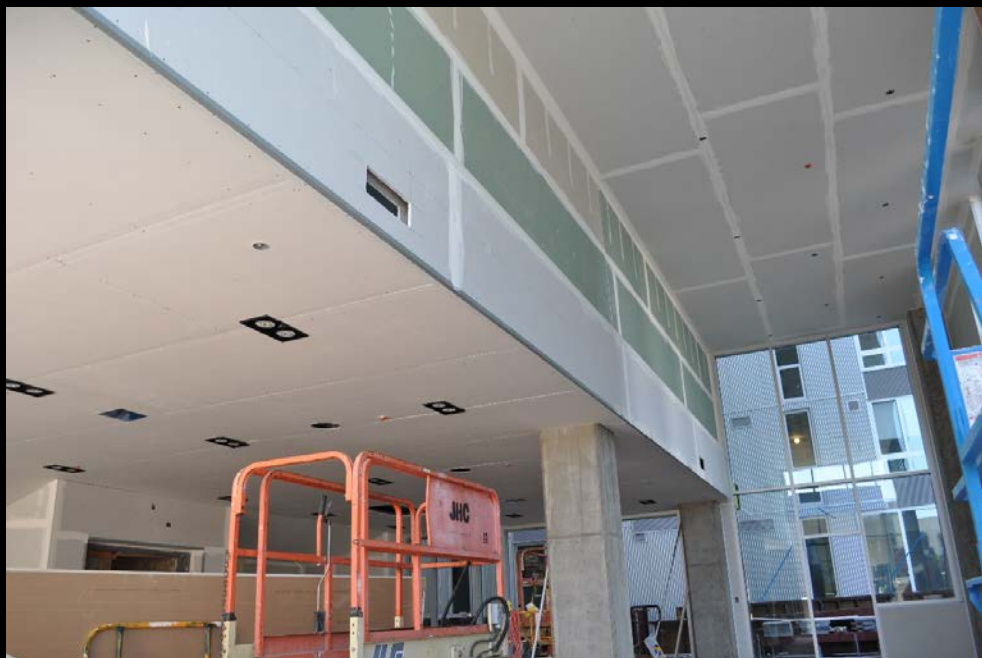
Drywall at Club Room
high ceiling

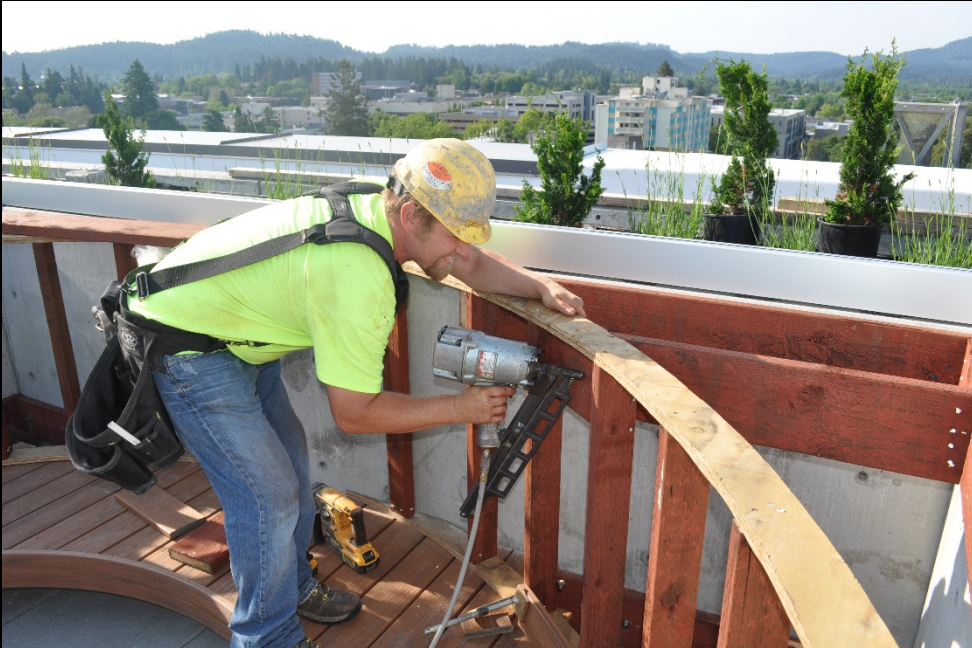
Bench framing at rooftop
fire pit

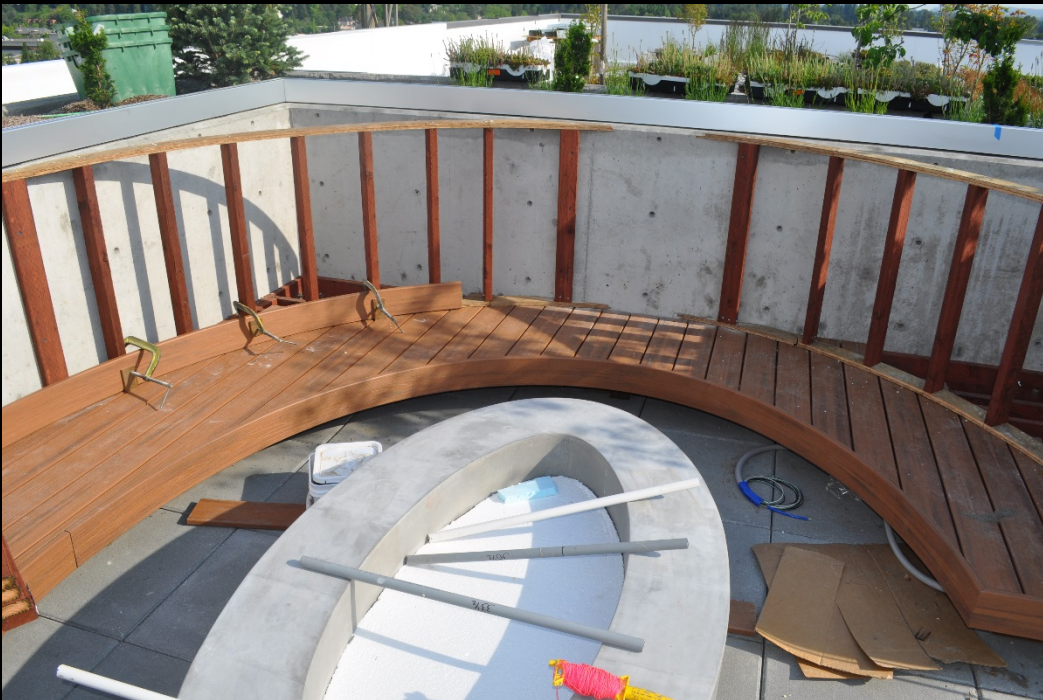
Trex deck benches at
rooftop fire pit

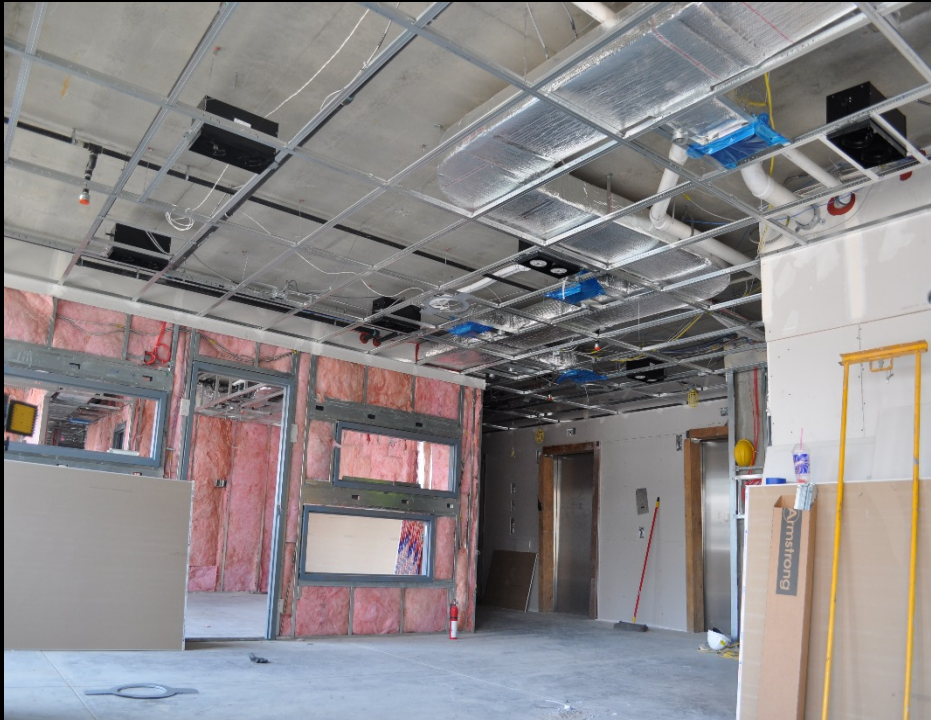
Ceiling rough-in and framing complete and wall insulation installed at level 1 Leasing

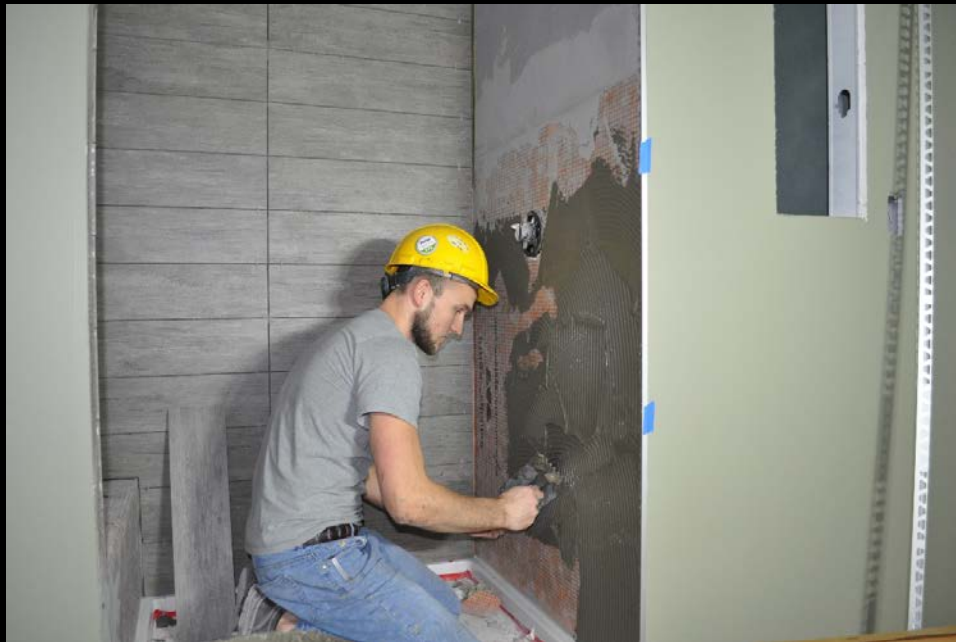
Ceramic tile installation at 12th floor showers
